IP54 TEST REPORT

EN 60529:1991/A2:2013/AC:2019-02

MODEL: C40

This Report Concerns: **Equipment Type:** Original Report Laser Distance Meter Enc Tow Test By: Eric Tao / Report Number: TH2211277-C02-R01 Test Date: 2022-11-18 to 2022-11-23 whe Hum Reviewed By: Prince Huang/ Zone Huone Approved By: Prince Huang/ Prepared By: Shenzhen Tian Hai Test Technology Co.,Ltd. 4F, A3 BLDG, The Silicon Valley Power Intelligent Terminal Industrial Park, Guan Lan Street, Longhua District, Shenzhen Tel: +86-755-86615100 Fax:+86-755-86615105

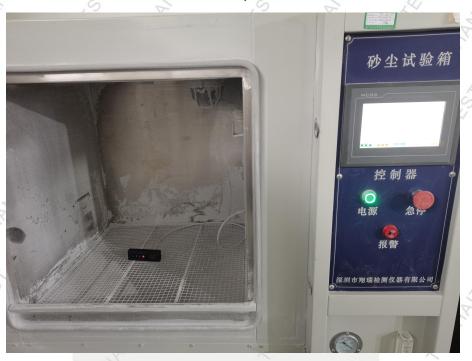
IP6X test photos

13.3	The first characteristic digital accept conditions (1, 2, 3, 4)	Not through any openings	Р	
13.4	The first characteristic Numbers for dust test 5 and 6	Test in the test chamber after 20 times, shell has no obvious dust	PWH	
~		deposition.	5

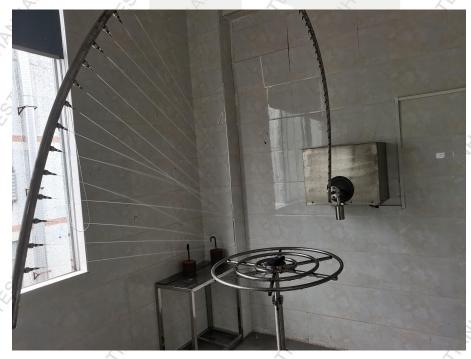
IPX4 test photos

14.3	Acceptable conditions	No ingress of water	P		
15 8	Additional letters represent close to the dangerous parts protection test				
15.1	Try (the) as stipulated in the table 6	5	N/A
